TROUBLE TRACER CHART

SYMPTOMS

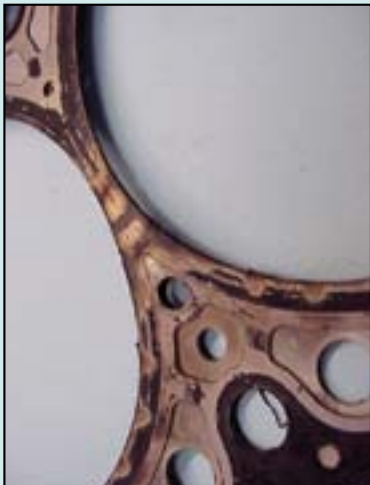
OVERHEATING

Symptom: Gasket materials are hard and carbonised. Surface cracks are evident. Bore eyelets are discoloured.

Cause: Overheating causes hardening of the gasket materials and possible material degradation. This will reduce the sealing effectiveness of the gasket.

Remedy: Maintain cooling systems in good order. Rectify leaks immediately. Replace cylinder head gasket if engine has been severely overheated. A planned repair is better than an unexpected failure.

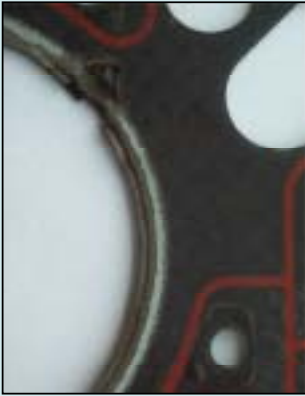
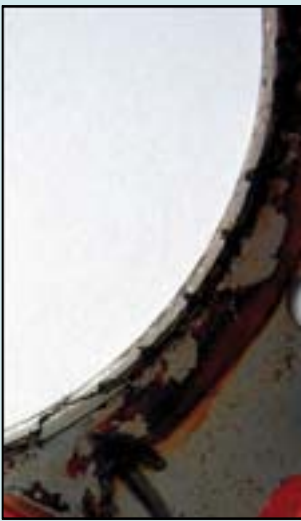
ABNORMAL COMBUSTION

Symptom: Gasket material is burnt away, often between cylinders, or at a location where detonation or pre-ignition occurs. Discolourations are indicative of elevated temperatures around the bore eyelets and combustion gas leakage paths are evident.

Cause: Detonation and pre-ignition increase the localised surface temperatures in the combustion chamber and damage the gasket by burning away the gasket material. In addition, the excessive cylinder pressures are generated which counteract the clamping load leading to a fatigue failure of the gasket bore seal.

Remedy: Keep the ignition system in good order. Ensure the spark plugs have both the correct heat rating and electrode gap. Use the correct grade of fuel specified for the engine and check the compression ratio if major engine machining operations have been undertaken.

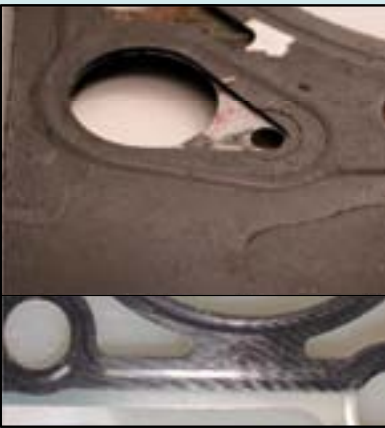
SURFACE FINISH

Recommendations: To ensure an effective seal between the cylinder head gasket and the joint face is obtained, the surface finish of the cylinder head must be taken into consideration. Too smooth a finish may allow gasket movement, resulting in failure. Too rough a finish will prevent adequate surface sealing between the gasket and the engine surfaces, allowing seepage to occur. The table below gives the approximate surface finish requirements in micromillimetres from the various types of gasket available. These are general guidelines but should be used when alternative OE specifications are unavailable.

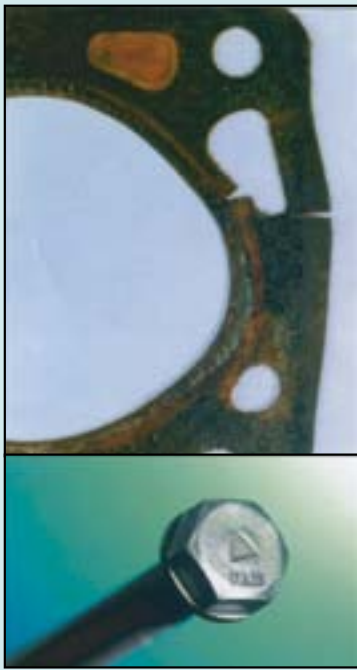
RETORQUE OMITTED

Symptom: Displacement of the gasket material and cracking of the bore eyelets due the clamping force reduction. Leakage occurs within the first few thousand miles.

Cause: Depending upon the type of material and construction, some cylinder head gaskets settle slightly when exposed to heat and vibration. If the cylinder head bolts are not retorqued after an initial period of engine operation, the clamping load is reduced and leakage occurs.

Remedy: Always follow the manufacturers' instructions about retorquing cylinder head bolts after a specified mileage. If the engine is to pass out of your control, clearly label it that a retorque will be required.
